Tank Failure Above Ground Storage Tank

Magnetec Inspection, Inc.

FAILURE INSPECTION OF ABOVE GROUND STORAGE TANK

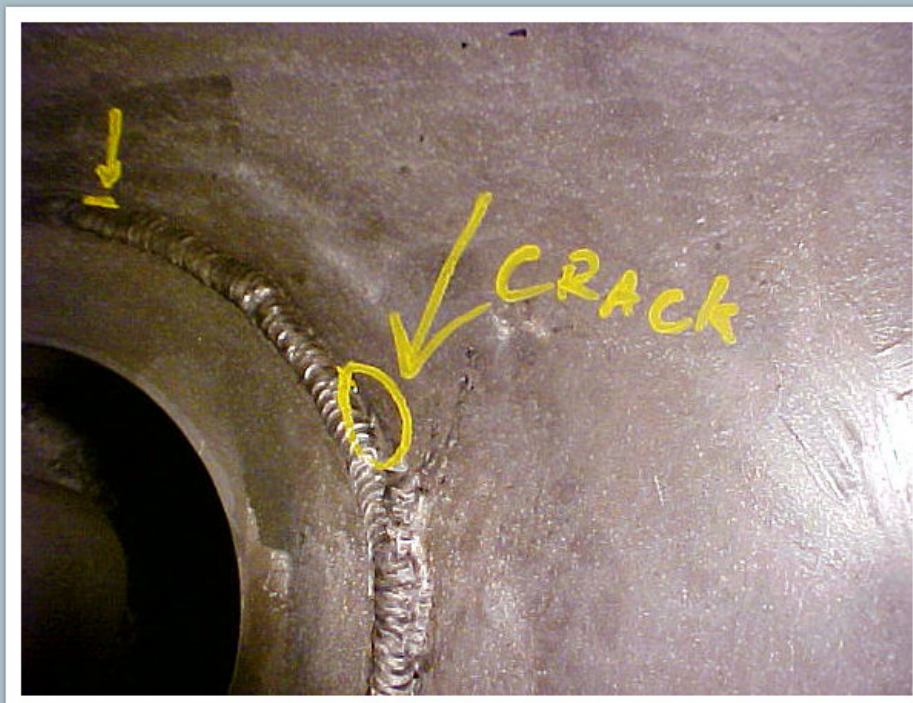
PHOTO #2
Crack Locations in Association with Sump/Drain

The inspection found crack structures in the HAZ (heat Affected Zones) of the fillet welds of the plate to sump/drain. The cracks were found as multi-branched type crack structures with orientations parallel with the weld contour of the sump/drain. The welds were free of defects which allowed for initiation of the crack structures. The cracks were open to the surface and determined (via ECT techniques) to have additional crack faces of greater geometry under the surface. One pin-hole type defect was detected however this was determined to be original weld porosity. Based on the service, the initiation factor of the tank product was not considered a driving factor in the crack formation.

- 1. Due to the findings of a small settlement of the tank the driving force for crack formation was considered a singular event and repairs were made accordingly.**
- 2. Any buckling force acting on the tank floor appeared in one defined location and did not appear to be an ongoing scenario and therefore no structural additions/repairs were made.**
- 3. A reinforcement ring was manufactured which covered the sump and HAZ of the floor materials and was welded in place.**

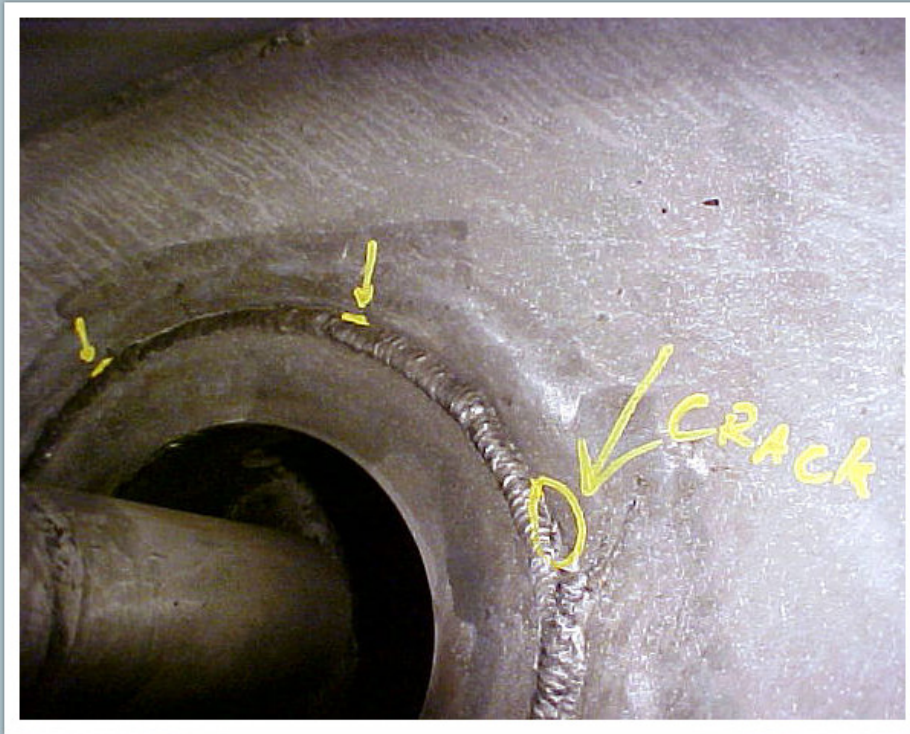
PHOTO #3

Crack Locations around Perimeter of Sump/Drain
3 Locations

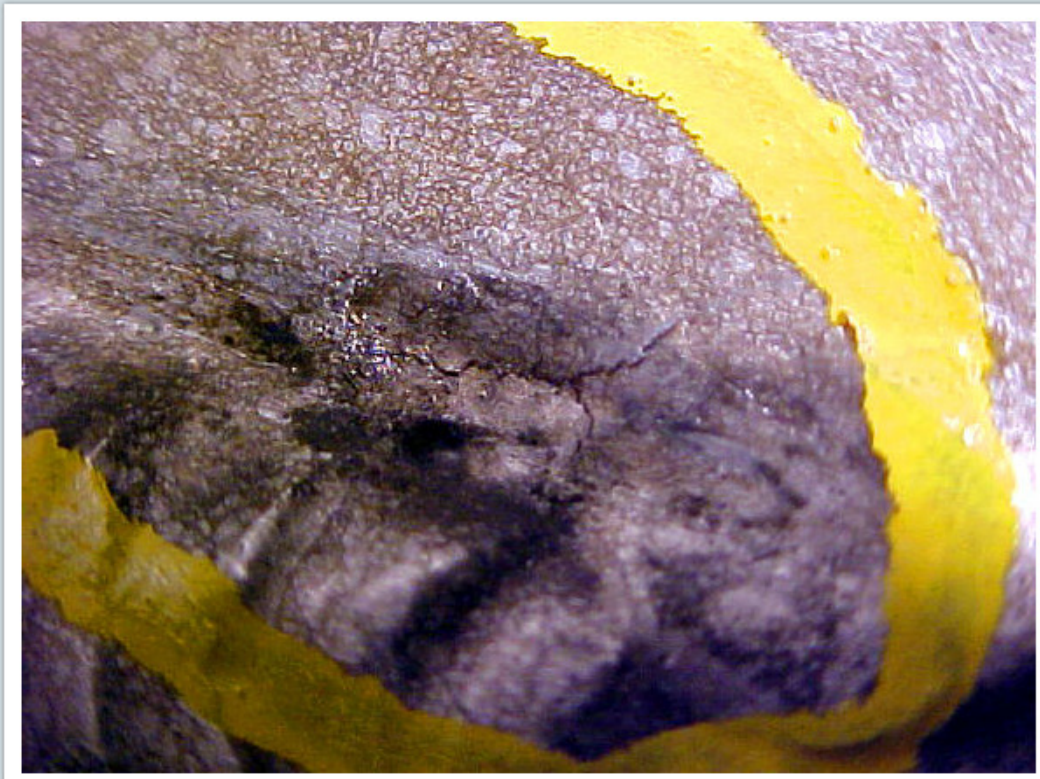
PHOTO #4

Crack Structure -- Branched Surface Defect

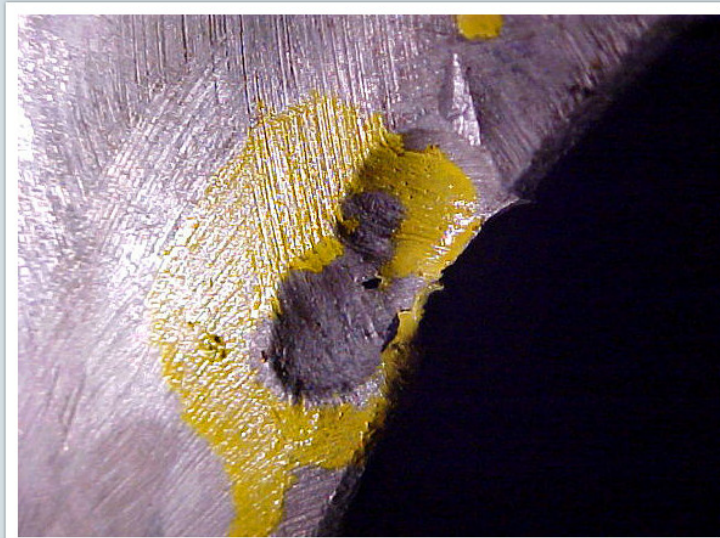
PHOTO #5
Pinhole Porosity Defect
